NAVAL POSTGRADUATE SCHOOL Monterey, California

THESIS

HOT CORROSION BEHAVIOR OF MODIFIED ALUMINIDE COATINGS ON COBALT-BASE SUPERALLOYS

Muhammad Yasin

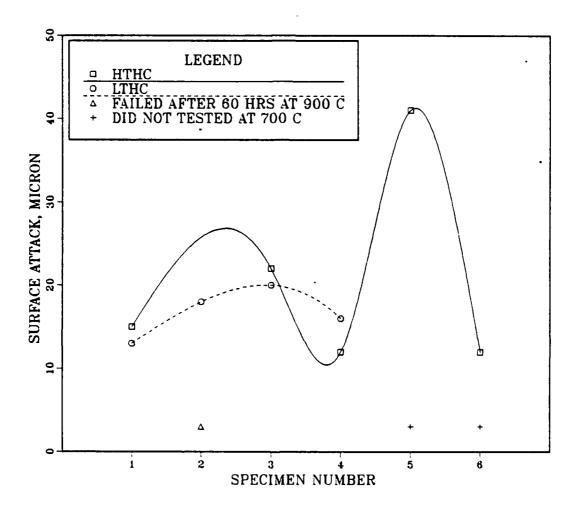
The level of hot corrosion attack of the various coatings on the MAR-M-509 substrate can be seen in Figure B.3. The Std-Al coating has a higher attack (15 microns) at high temperature than at low temperature (13 microns). The difference between these two attacks is in a small range. Figure B.12 shows typical SEM photomicrographs of the as-received, LTHC, and HTHC test specimens with the Std-Al coating on MAR-M-509 substrate. It can be seen that the standard aluminide coating has a three zone structure similar to that observed on nickel-base superalloys [Ref. 5]. Unfortunately, the phase identification of this coating on cobalt-base superalloys has not yet been investi-There is no significant hot corrosion attack on gated . this coating at both high and low temperatures.

Tigure B. High and low termenature how corrotion behavior of various coatings on the H-500 substrate.

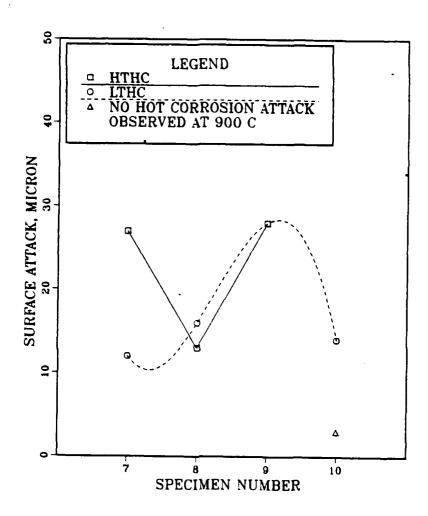
Hot corrosion attack results of the various coatings on the X-40 substrate can be seen in Figure B.4. The Std-Al coating has a higher hot corrosion attack (27 microns) at high temperature than at low temperature (12 microns). The difference between these two attacks is fairly large (15 microns) but it is still lower than the difference observed on nickel-base superalloys (IN-738 as a control sample). Figure B.17 shows typical SEM photomicrographs of the Std-Al coating where the three zone structure is clearly shown. No significant attack can be observed in this particular section. As mentioned earlier, no work has been done with X-Ray diffraction analysis to identify the phases present in the various coatings on cobalt-base superalloys.

The Pt-Al coating has a lower hot corrosion attack (13 microns) at high temperature than at low temperature (16 microns) although the difference between these is quite

Figure 3.4 High and low temperature hot corrosion behavior of various coatings on $\mathbb{N}\!\!=\!\!0$ substrate.

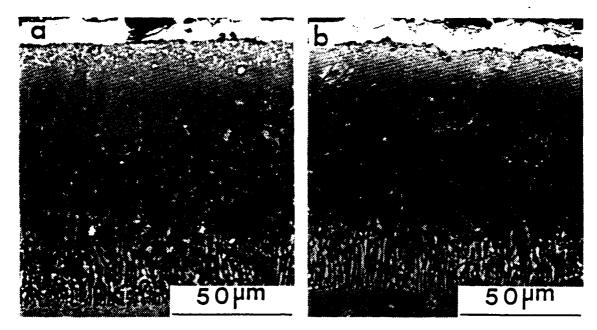
The Pt-Al coating has a higher amount of attack at high temperature than at low temperature (18 microns). At the high temperature, the coating failed after only 60 hours of testing. At both high and low temperatures, the Pt-Al coating showed higher attack than the Std-Al coating. Figure B.13 shows typical SEM photomicrographs of the Pt-Al coating in which the three zone structure is shown. It can

Figure B.13 OET photomicrographs of Pt-Al coatings in MAP-M-N-9 objects that (a) exposed 200 hrs at 400 0. (b) exposed with hrs at 700 0 and (c) as-received.

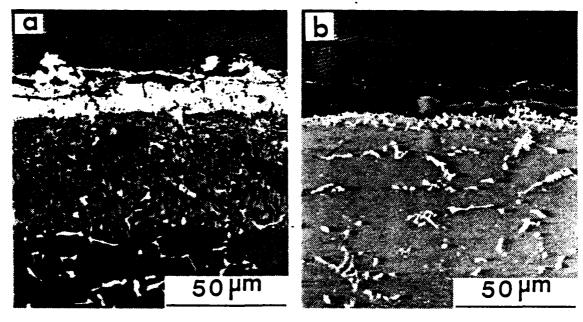
The Pt-Cr-Al coating has a higher attack (22 microns) at high temperature than at low temperature (20 microns). The difference between these two penetrations is as described with the Std-Al coating. At both high and low temperatures, the Pt-Cr-Al coating showed higher attack than either the Std-Al or the Pt-Al coatings. Figure B.14 shows typical SEM photomicrographs of the Pt-Cr-Al coating with its three zone structure. There is no significant hot corrosion attack evident in this section.

Tigure 3.14 OII (hotomicrographs of Pt-Or-Al coatings on OAR-M-509 substrate: (a) exposed 200 hrs at 300 O. (b) exposed to one at 700 O and (c) as-received.

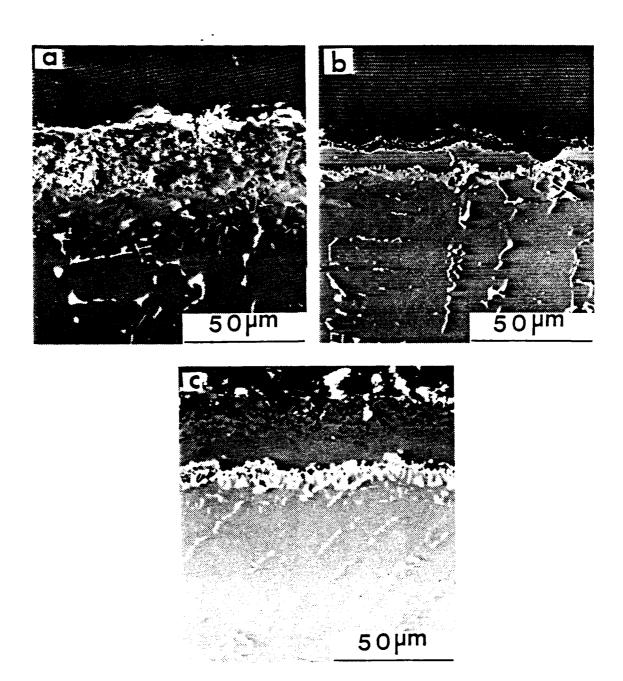
The CVD-Low Al coating has a lower amount of attack (12 microns) at high temperature than at low temperature (16 microns) although the difference between these two attacks is small. This coating has a lower attack than the Std-Al, Pt-Al, or Pt-Cr-Al coatings at high temperature. At low temperatures, the attack is less than for the Pt-Al and Pt-Cr-Al coatings. Figure B.15 shows typical SEM photomicrographs of the CVD-Low Al coating. It can be seen that there is a less defined three zone structure. There is no significant attack can be observed at high temperatures.

Figure B.15 SEM photomicrographs of SVD-Low Al coatings on NVE-U-DOV rubotrate: (a) exposed 100 hrs at 300 %, (b) exposed to hrs at 700 % and (b) as-received.

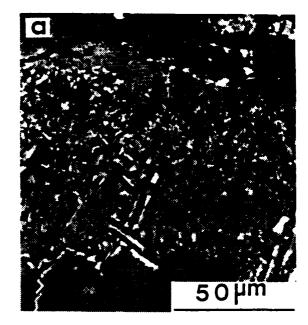
The Rh-Al coating has a higher hot corrosion attack (41 microns) as compared to the attack of other coatings on the

MAR-M-509 substrate at high temperature. The Rh-Pt-Al coating has the same hot corrosion attack (12 microns) as the unmodified CVD-Low Al coating both tested at high temperature. Figure B.16 shows typical SEM photomicrographs of the Rh-Al and Rh-Pt-Al coatings at high temperature, respectively. Because of a lack of specimens no low temperature testing were performed.

Figure 3.18 CEM photomicrographs: (a) Ph-Al coatings and (b) Ph-Pt-Al coatings on MAR-M-809 substrate both emposed 200 hrs at #00 %.

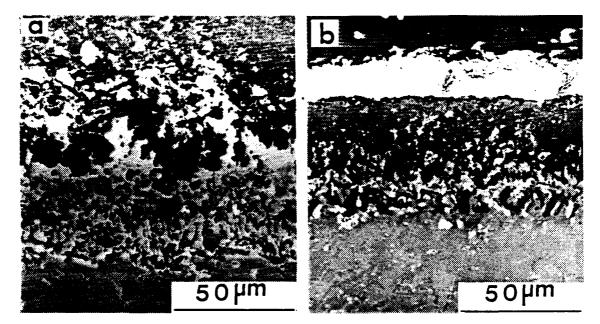
Tigure 8.17 CEM photomicrographs of Std-Al scatings on N-+0 substrate: (a) exposed 500 hrs at 300 0, (b) exposed 60 hrs at 700 0 and (c) as-received.

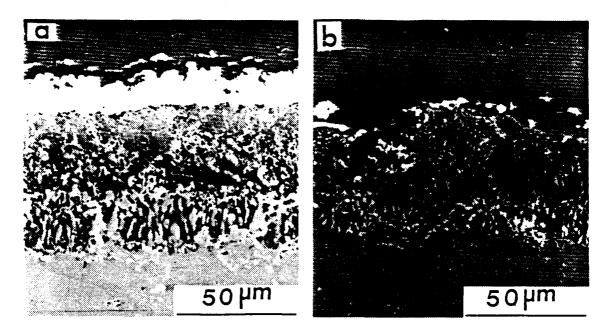
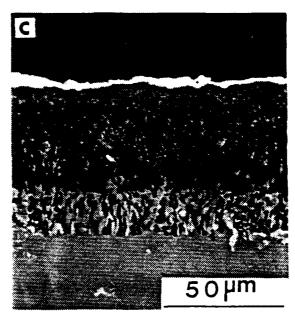
Titure 8.13 CIM photomiomographo of St-Al coatings on N-40 substracts (a) exposed 200 hmb at 300 l. (b) exposed 31 hms at 71 and (c) a separation.

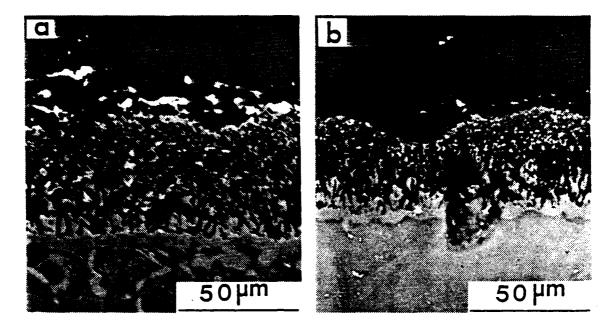
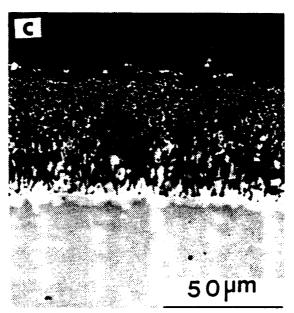
Tigure 8.20 DEM photomicrographs of Oti-Al coatings on ESM-414 gubstrate: (a) exposed 200 hrs at 300 0, (b) exposed 50 hrs at 700 0 and (c) ac-received.

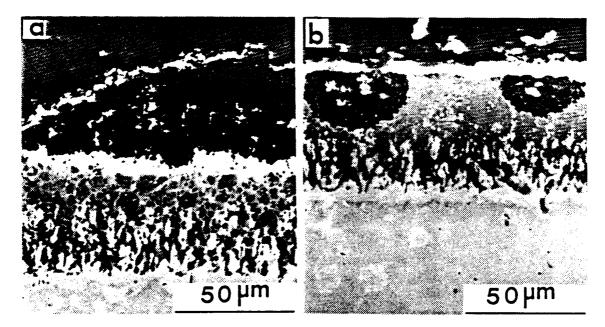
Frome F.21 CCM phutomicrosphaphs of Pt-Al coatings on FSM-414 substrate: (a) emposed 100 has at 300 %, (b) emposed +0 mrs at 700 % and (b) ab-received.

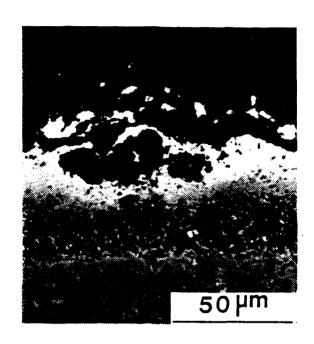
Figure B.23 SEM photomicrographs of Rh-Pt-Al coatings on FSN-414 substrate exposed 200 hrs at 900 C.
